Manhole Inspection Summary

Manhole # S43K__040MH

Insp Date: **6/3/08 3:33 PM**

Location Address: **700 s bond st**

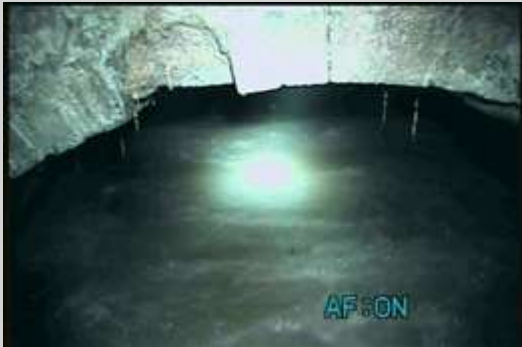
12 O'Clock Outflow

42 in. Circular Gravity Sewer
Pipe Out @ 12 O'Clock

Pipe Material: **Clay** ☐ Pipe Lined

Invert Depth: 14.41 (ft.) Flow Characteristics: **Fast**

Deposits: ☒ None ☐ Mud ☐ Sludge ☐ Debris ☐ Grease

Infiltration: **None** Pipe Seal Cond: **Unknown**

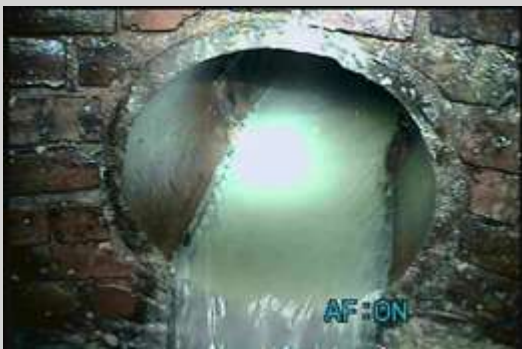
3 O'Clock Inflow

12 in. Circular Gravity Sewer
Pipe In @ 3 O'Clock

Pipe Material: **Clay** ☐ Pipe Lined

Invert Depth: 12.69 (ft.) Flow Characteristics: **Fast**

Deposits: ☒ None ☐ Mud ☐ Sludge ☐ Debris ☐ Grease

Infiltration: **None** Pipe Seal Cond: **Unknown**

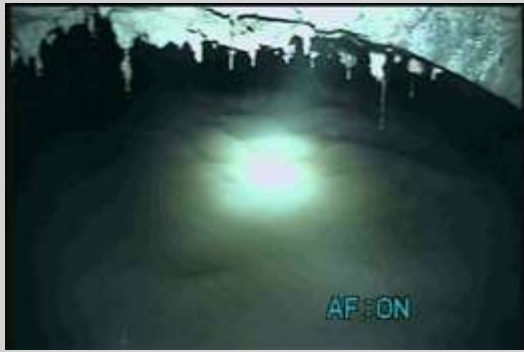
6 O'Clock Inflow

42 in. Circular Gravity Sewer

Pipe In @ 6 O'Clock

Pipe Material: **Clay** ☐ Pipe Lined

Invert Depth: 14.30 (ft.) Flow Characteristics: **Fast**

Deposits: ☒ None ☐ Mud ☐ Sludge ☐ Debris ☐ Grease

Infiltration: **None** Pipe Seal Cond: **Unknown**

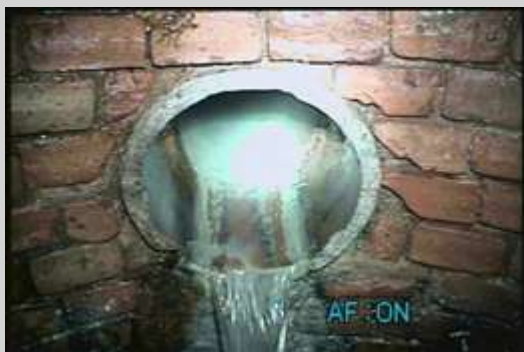
9 O'Clock Inflow

8 in. Circular Gravity Sewer

Pipe In @ 9 O'Clock

Pipe Material: **Clay** ☐ Pipe Lined

Infiltration: **None** Pipe Seal Cond: **Unknown**
